NPDES Permit Number: MAR10D585

Project Name: **Route 62 Roadway Resurfacing and Reconstruction**
Project Address: Route 62 Concord, Massachusetts
Project Proponent: **Town of Concord Public Works/ MHD**
Report Prepared By: Mary Trudeau, Environmental Consultant
Date of Report/Site Visit: October 23, 2009

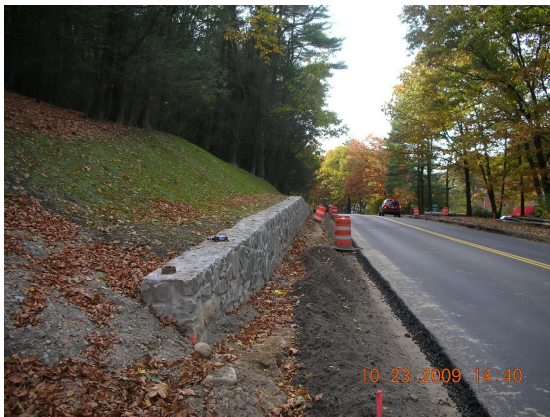
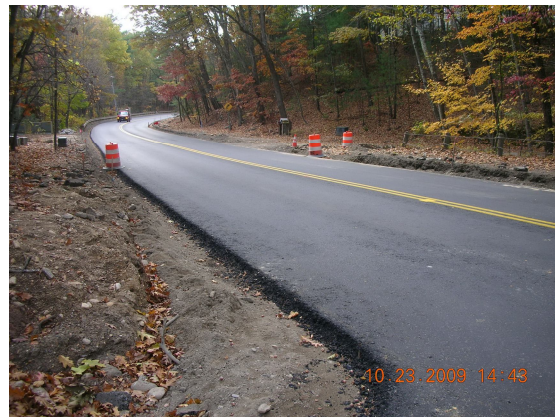
Weather this work week was seasonable with insignificant or trace rainfall events. There was a prediction for heavier rainfall on the weekend of October 23/24, 2009, and there was some light precipitation at the time of my visit. At the date of my visit on October 23, 2009, it was apparent that work had progressed throughout the week. The roadway was completely paved, striped and driveway apron and shoulder work was ongoing.

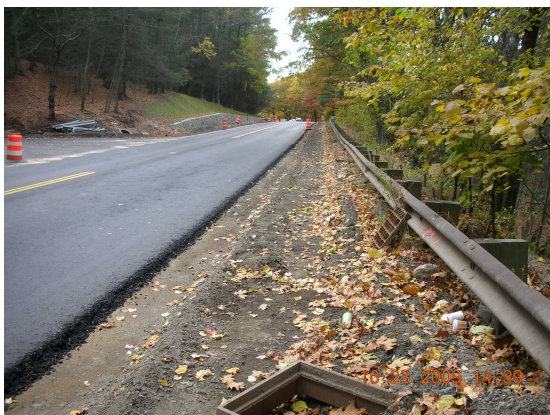
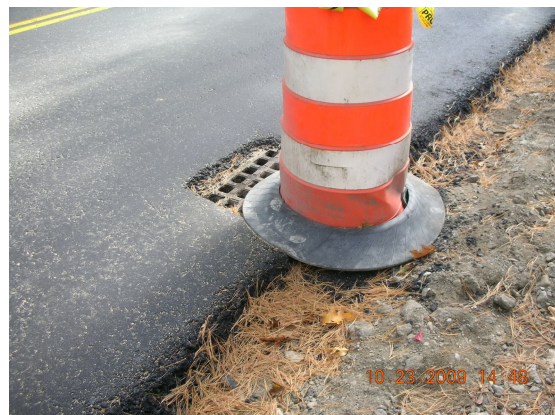
Catchbasins were either protected or paved over at the time of my visit. I did find one or two grates that were not lined, but neither was in an area likely to receive sediment laden flows due to current grading. The following photos show both the “missing catchbasins” and one of the unlined basins:

2. As catch basins are cut out of the newly paved areas, the contractor should install liners when unstabilized slopes will discharge sediment to the basins during rain events.

7. After a rain event, inspect each catch basin liner. Torn liners should be replaced; silted liners should be removed, cleaned and replaced.
8. In general, pavement adjacent to catch basins should be swept or shoveled to remove excess sediment deposits from the perimeter of the catch basins.

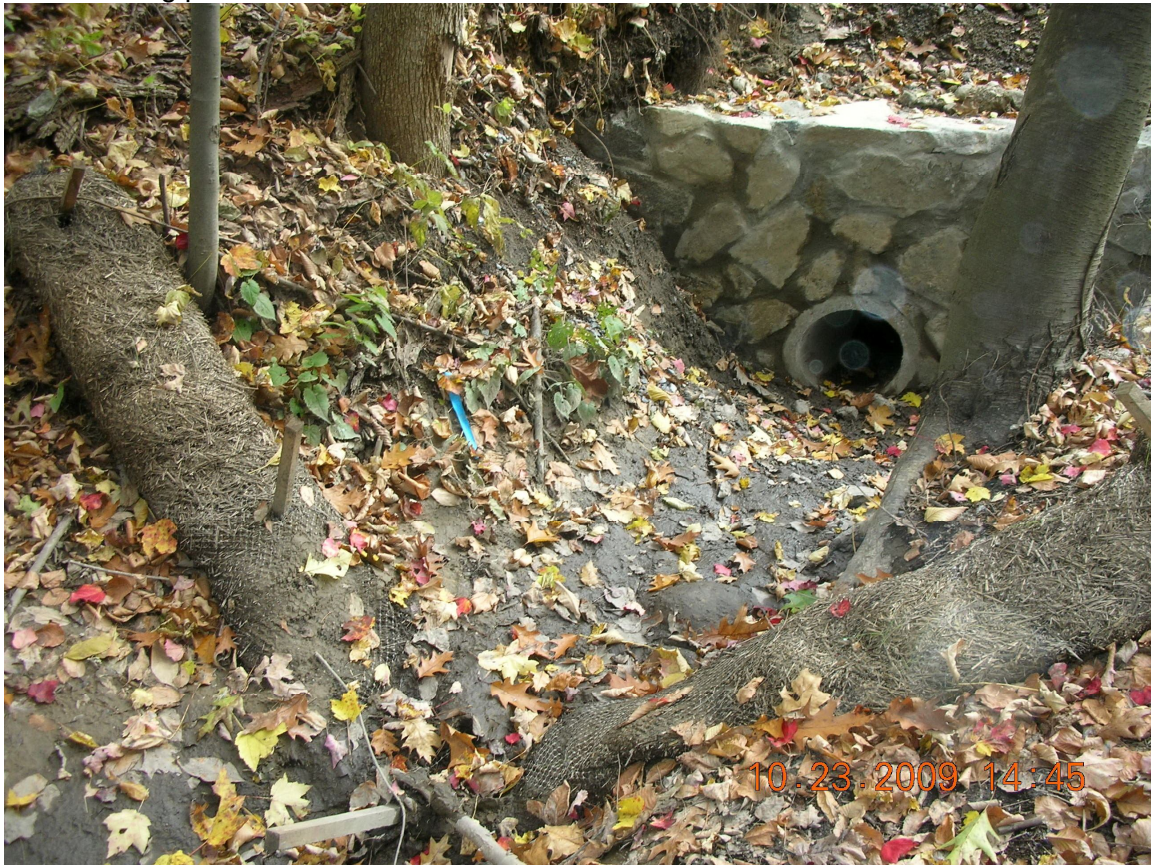
Last week the contractor rebuilt the outfall on the north side of Route 62, located at station point 23+25. While the shoulder has been rebuilt and is relatively stable, the work resulted in the deposition of fine silty sediment within the area between the culvert

and the down gradient erosion controls. I would recommend hand removal of the sediments, and adding stone to the outfall to stabilize the channel below the culvert. The following photo shows this area of concern:

As can be seen in the first photo, there is an accumulation of fines on the check dam/wattle immediately below the outfall. While there is silt fence and haybale check

dam below, this wattle is now acting to discharge sediment as the flows from the culvert pass over or through the wattle. I would recommend replacing this wattle, or shifting it so that an unsilted section of the wattle lies across the flow path.

1. The contractor should rebuild the erosion controls below the new headwall at station point 23+25 on the north side of Route 62. This task should include hand removal of the accumulation of fine sediments above the existing checkdam.

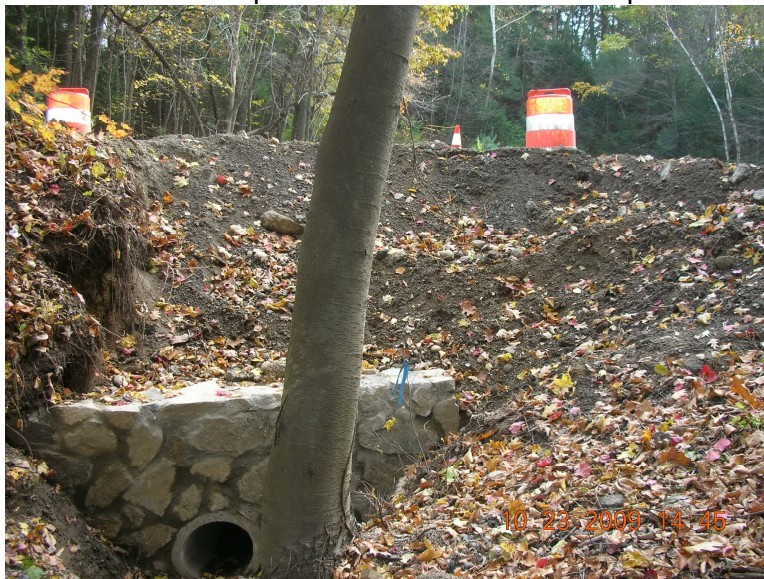
And the photo below shows the top of the headwall and the slope below the roadway:

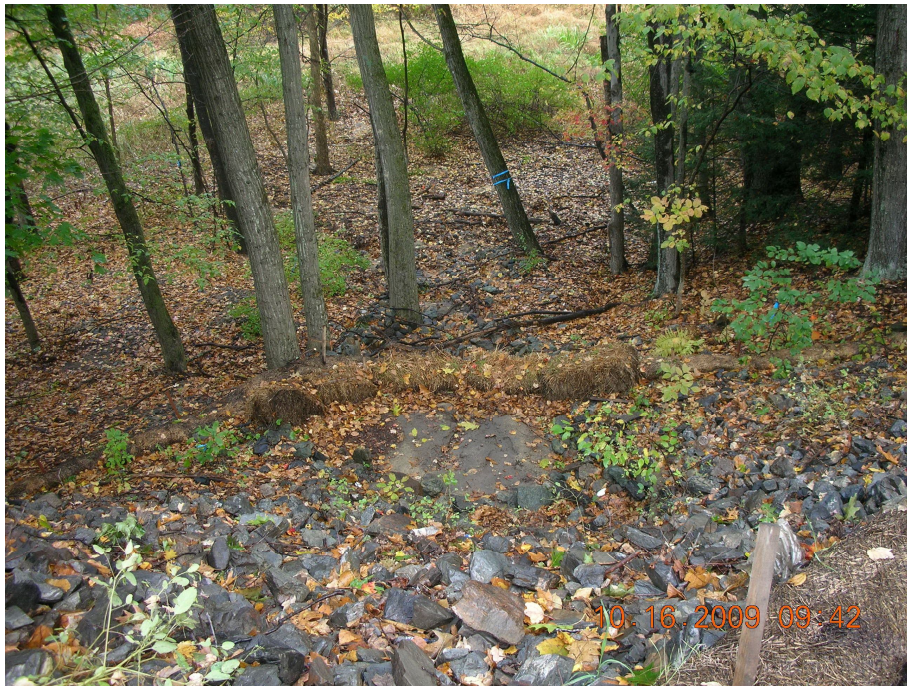
I continue to have some residual concern with the outfall at station point 15+00, on the north side of Route 62. While the erosion controls looked intact, it was apparent that there has been some historic discharge of sediment to downgradient buffer zone and wetland resource areas. While I suspect the discharge happened several weeks ago, the recent die back of the herbaceous plants in the locus has revealed the drainage patterns below the outfall. While the accumulations are not significant, the contractor should send a laborer to rake and remove any deposits of material. The following photo shows this area on October 18, 2009:

3. The contractor should address the sedimentation that has occurred down gradient of the drainage outfall at station point 15+00. Raking and hand work is the appropriate remediation.

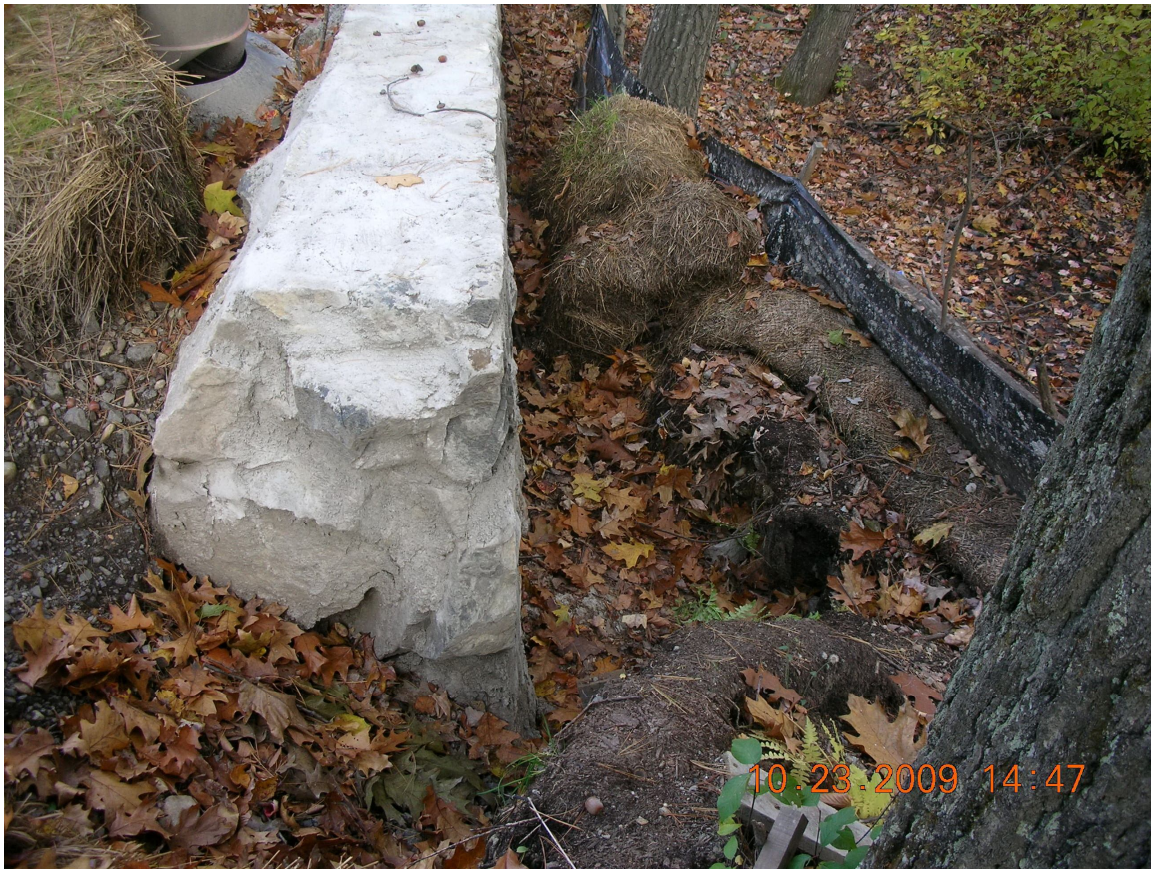
As noted in earlier reports, I am concerned with the upcoming detailing of the slope adjacent to either end of the easternmost retaining wall. This wall is located at approximately station point 27+50, on the south side of Route 62. I have spoken with Alan Visco of EH Perkins Construction and noted that I am concerned that the work should include stone and hand work to stabilize the area at either end of the wall. The contractor should insure, particularly on the eastern end of the wall (left hand photo below) that the materials used to stabilize the slope utilize the erosion controls for support. The toe of the finished slope should be set, and stabilized, at the back side of the retaining wall, and should not encroach onto the down gradient silt fence barrier. The following photo shows the areas of concern:

4. The contractor should consider the slope treatment of either end of the retaining wall at station point 27+00, on the southern shoulder of Route 62, and should plan on hand work in the more sensitive areas.

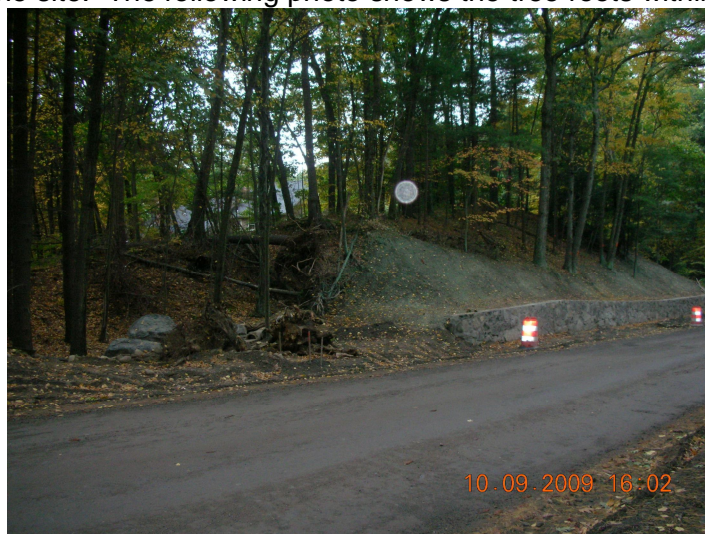
Also noted in earlier reports, Mrs. Sulewski, a condominium owner on Cranberry Lane noted that a tree fall at the south side of Route 62, at approximately station point 25+75 has fallen into and across her yard. Alan Visco and Minot Wood of EHPerkins Construction have determined that the tree fall is within forty feet of the centerline of the road (and is their responsibility) and that it will be cut and removed when the tree cutting crew returns to the site. The following photo shows the tree roots within the job locus:

5. The contractor should remove the tree fall at station point 25+75. It should be cut and removed from the site.
6. There is also a little pile of slash on the south side of the erosion controls at station point 28+25 (south side of Route 62) that should be pulled and disposed of off site. This was left by the tree cutters in the initial clearing of the site.
